LANDSAT 3 RETURN BEAM VIDICON RESPONSE ARTIFACTS:

A Report on RBV Photographic Product Characteristics and Quality Coding System

EROS Data Center
U.S. Geological Survey
Sioux Falls, South Dakota 57198

August 1981

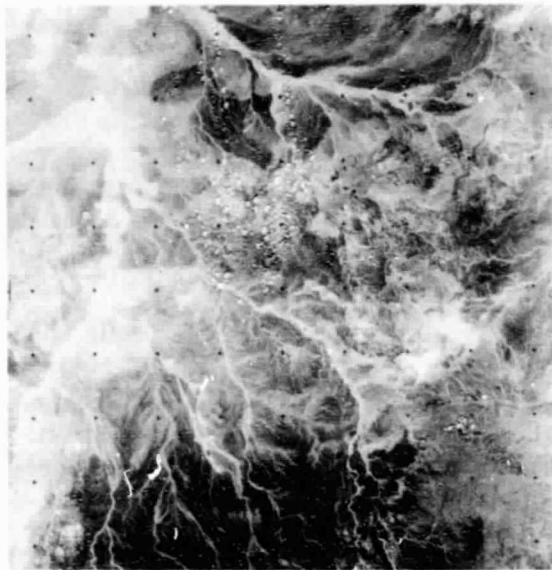
Figure 2A. Example of a Quality "8" RBV Image

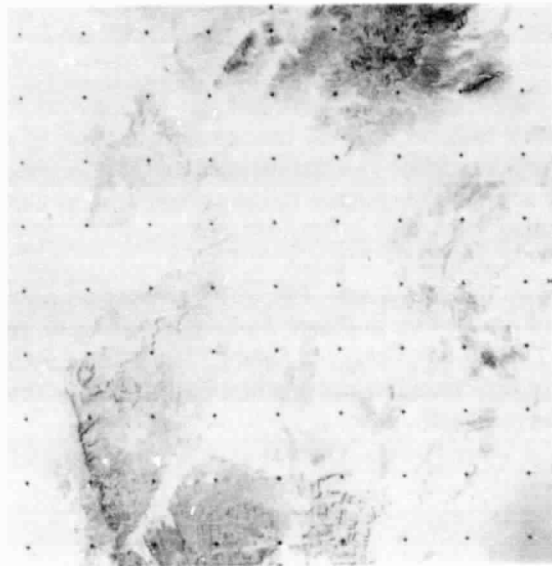
Figure 2C. Example of a Quality "2" RBV Image

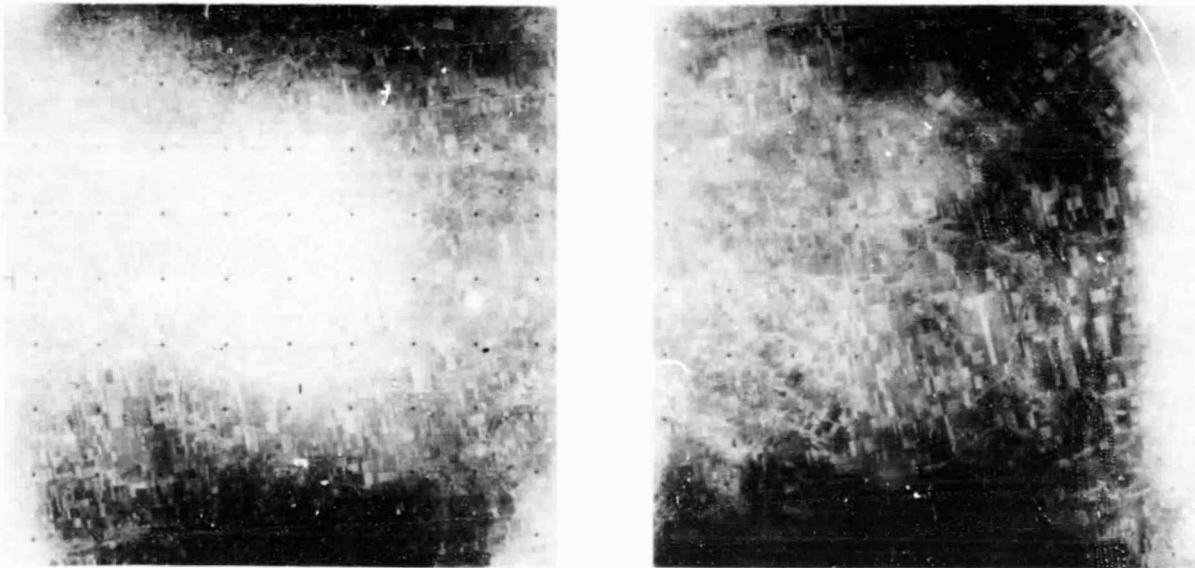
Shading is most obvious when the data acquired lie within a relatively narrow range of gray levels. Differences from camera to camera can be seen in Figure 3 where overall scene density varies considerably between two adjacent subscenes. The left-hand image in Figure 3 also shows how variations in camera response from point to point across the camera faceplate can produce camera-unique shading patterns. Some shading is evident in the right-hand image, as well.

Figure 3. Examples of Shading in Two Adjacent Subscenes

The prelaunch tests were performed in order to collect enough information to minimize these differences during ground processing after launch. Although minimization has been accomplished, it has been impossible to remove these effects totally. The result is a residual, spatially-varying, gray-level-dependent shading in most RBV images. Shading is unique to each subscene, and it affects some images more than others.

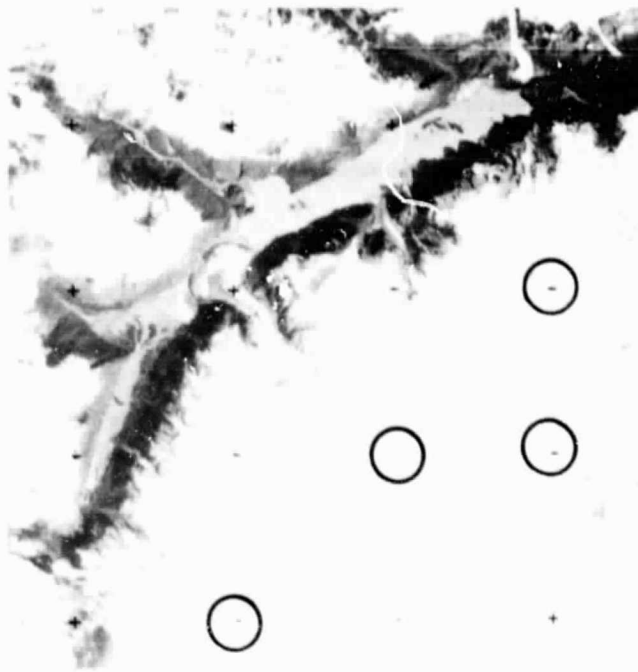
The reseau marks that have been inscribed on the faceplate of each camera can appear to be lost in an image when they occur among data that lie at either radiance extreme. For low-radiance data, the reseaus merge into the background and are obscured. For high-radiance data, the reseaus can be washed out or lost due to a vidicon characteristic called "blooming." The latter effect is probably a result of the gain setting on the RBV sensor and cannot be corrected by ground processing. Figure 6 is an enlargement of an image where high-radiance image data have caused reseau marks to be missing.

Figure 6. Examples of Incomplete or Missing Reseau Marks

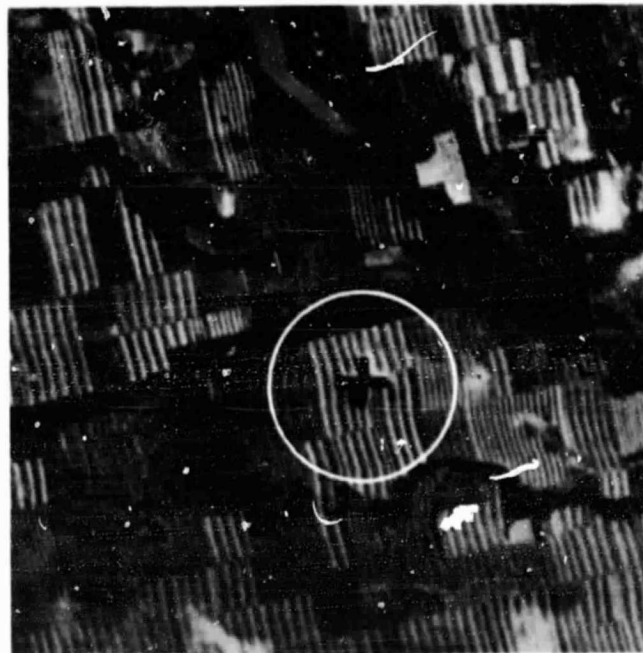
Distortion in reseau marks and image data can occur when the raw data contain time-code-induced anomalies. The enlargement in Figure 7 contains some reseau marks that are badly curved, and the image data near them, as well as elsewhere, are similarly distorted. Minor data losses in the time-code signal are thought to cause this horizontal shifting of data. Although this effect is not restricted to any area in an image, it is usually most pronounced in the corners of the image.

Figure 7. Examples of Data Distortion

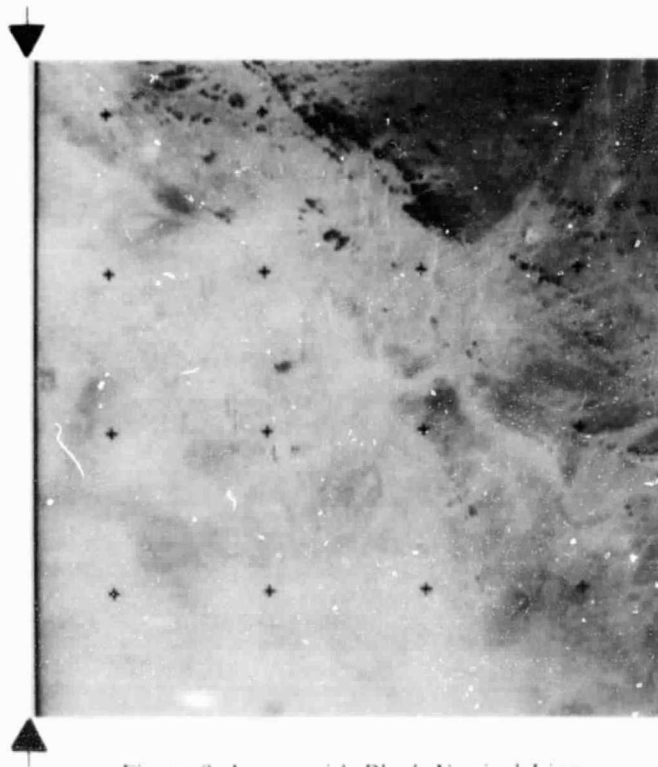
Image data acquired by camera no. 2 (which acquires subscenes B and D) contain a thin black line along the left vertical edge of the image. This is evident when the left edge of the image contains high-radiance data. Figure 8 is one example. This artifact occurs as a result of both hardware and software problems in the ground processing system. Its impact on image quality is strictly cosmetic, and it is shown here more for completeness than for any other reason.

Figure 8. Image with Black Vertical Line

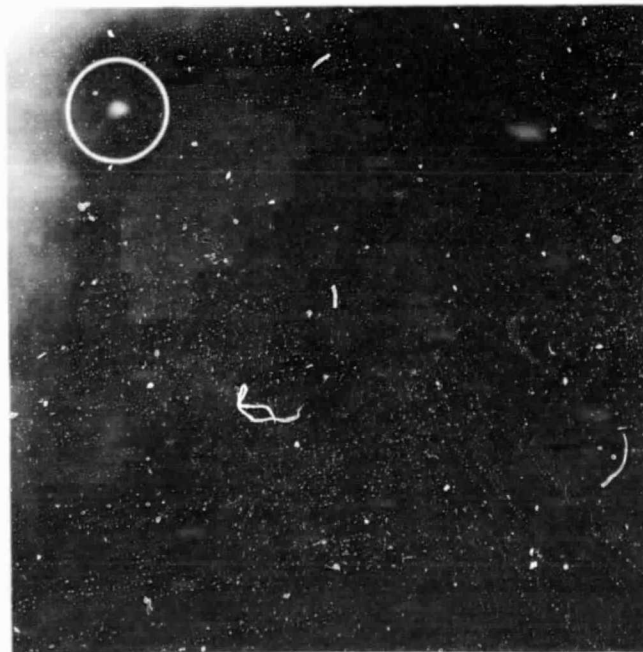
Figure 10 shows an example of a hot spot in the upper left corner of the image. It correlates to a flaw in the photoconductive layer of the vidicon, appearing as a blurred white spot. Hot spots are repeatable from image to image and their prominence is dependent upon the gray level of the image data written over them. Other hot spots exist in Figure 10 but are not as noticeable. Visual detection of hot spots is possible only when the average background scene radiance is low enough to permit them to stand out.

Figure 10. Example of Hot Spot

Both types of faceplate contamination, hot spots and tears, are uncorrectable by ground processing.

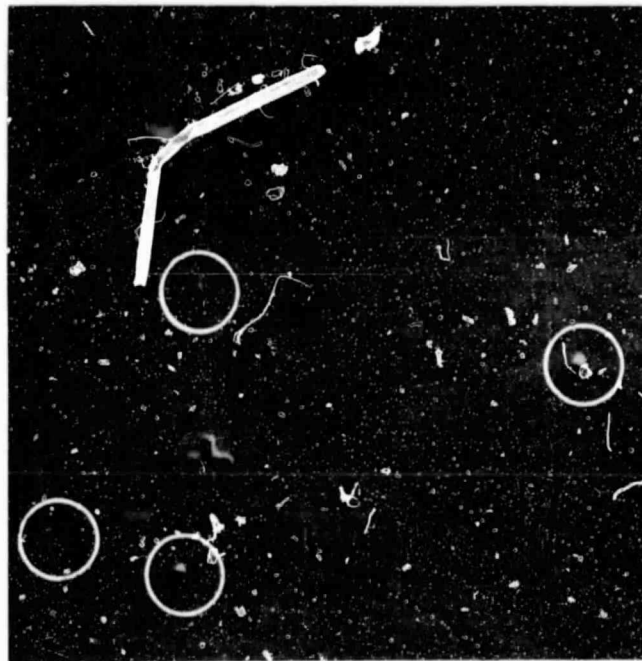
The second type of faceplate contamination cannot be seen clearly unless the proper combination of sun angle and scene radiance exists. When these conditions exist, one can detect bright white pinhole-size spots that are each accompanied by a black "shadow" of unknown origin. These are termed tears. The enlargement in Figure 11 has examples of tears; at this scale the tear shadows actually seem to be the dominant feature. Tears can be attributed to two causes. In some cases, they are a manifestation of minor flaws in the photoconductive layer of the vidicon. In other cases they represent localized areas of condensate on the camera faceplate. They always occur in the same place, and their detection is dependent upon the gray level of the image data written over them. They appear to be permanent.

Figure 11. Examples of Tears
